## Looking Back and Forward: Could Safety Indicators Have Given Early Warnings about the Deepwater Horizon Accident?

Keywords: Deepwater Horizon; deepwater drilling; risk management; safety indicators

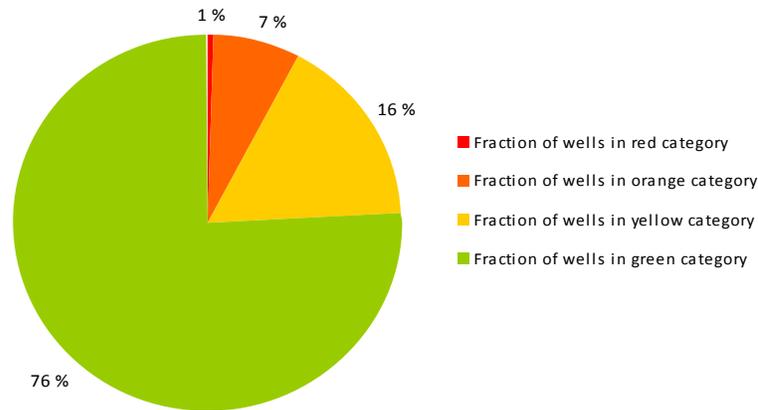
The RNNP survey for 2009 covers a total of 1712 producing wells on the NCS and eight operator companies; BP, ConocoPhillips, Exxon Mobil, Norske Shell, Statoil, Marathon, Talisman and Total (in random order). Figure 4.1 shows well categories by percentage of the total number of wells, 1712.

Figure 4.1 – Well classification –category red, orange, yellow and green, 2009.

The results show that 8 % (11 % in 2008) of the wells have reduced quality in relation to the requirements for two barriers (red + orange category). Sixteen percent (13 % in 2008) of the wells are in the yellow category, including wells with reduced quality in relation to the requirement for two barriers, but the companies have implemented various compensatory measures to meet the two-barrier requirement. The remaining wells, i.e., 76 % (as in 2008), fall into the green category meeting the requirement for two barriers in full.

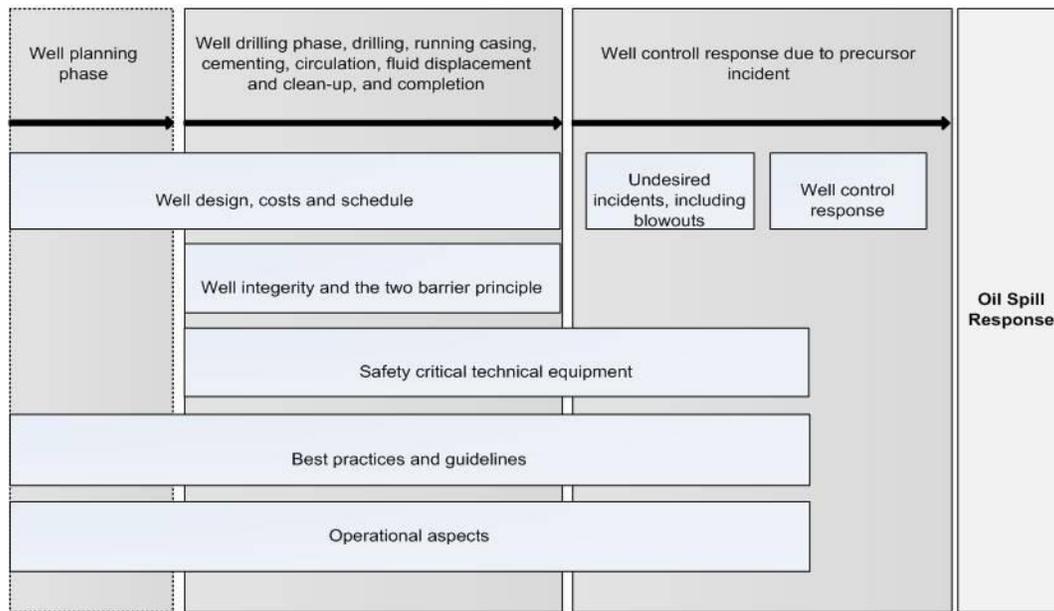
Figure 5.1 gives an overview of the main lifecycle phases of the well and aspects related to undesired incidents and relevant barriers of deepwater drilling. The different areas relevant for extending or supplementing safety indicators from RNNP with respect to well integrity are discussed thereafter.

Figure 5.1 – The life cycle phases of a well (excluding production).
